Evaluation of Prefabricated Edge Drains in Ohio

Abstract

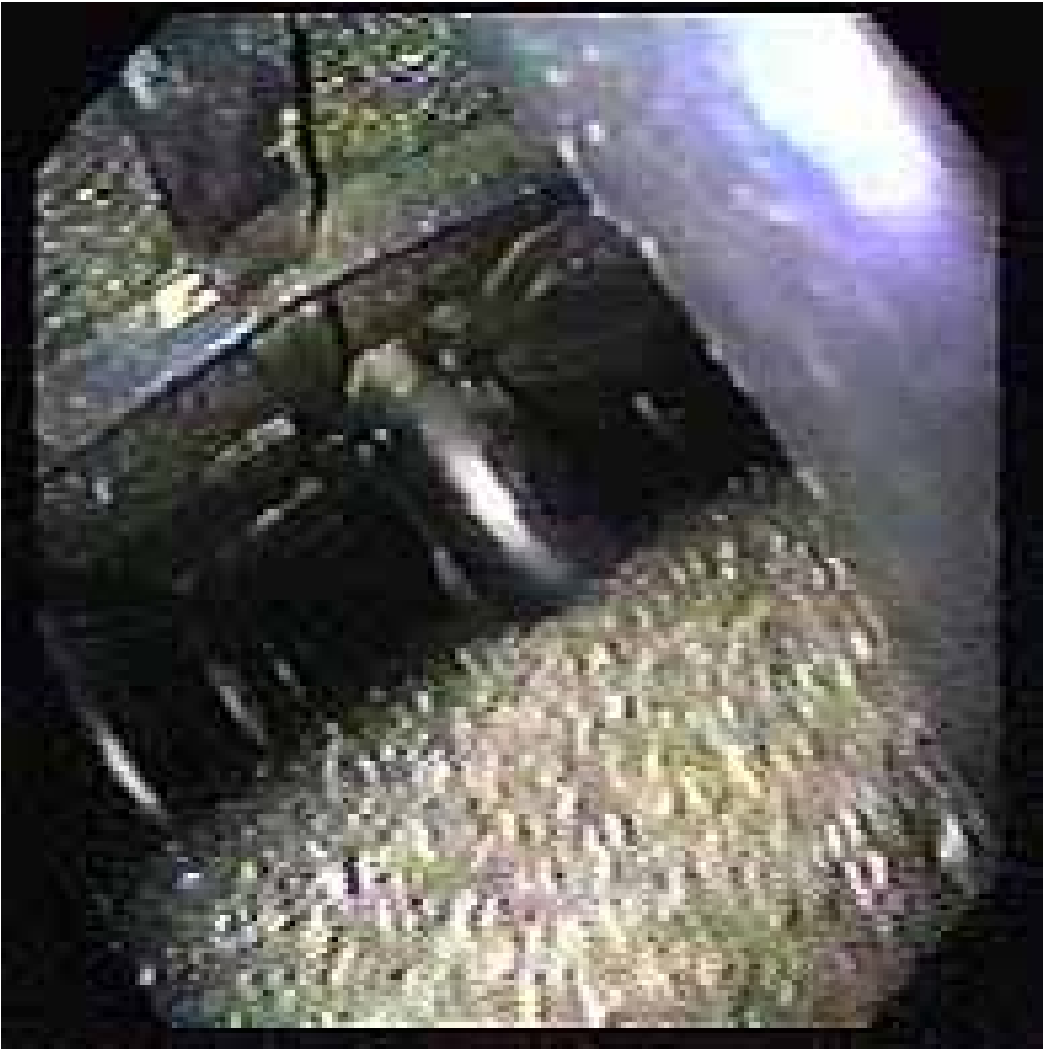
Figure 1 - Video Borescope Picture Showing Clean Fabric Material

A video borescope probe with a 25-foot fibreoptic cable was used for the investigation. The probe was advanced the full 25 feet wherever possible. Example video pictures showing either no problems or major problems with fabric siltation, fabric compression into the core and compression of the core are provided in Figures 1 through 6. It was not possible to advance the probe near the bottom of the PED at five of the sections because of J'ing of the core. In some cases the probe was advanced but silt blocked the lens so it was not possible to view the PED. There was compression of the core near the top of the PED at three locations that prevented the probe from being advanced.

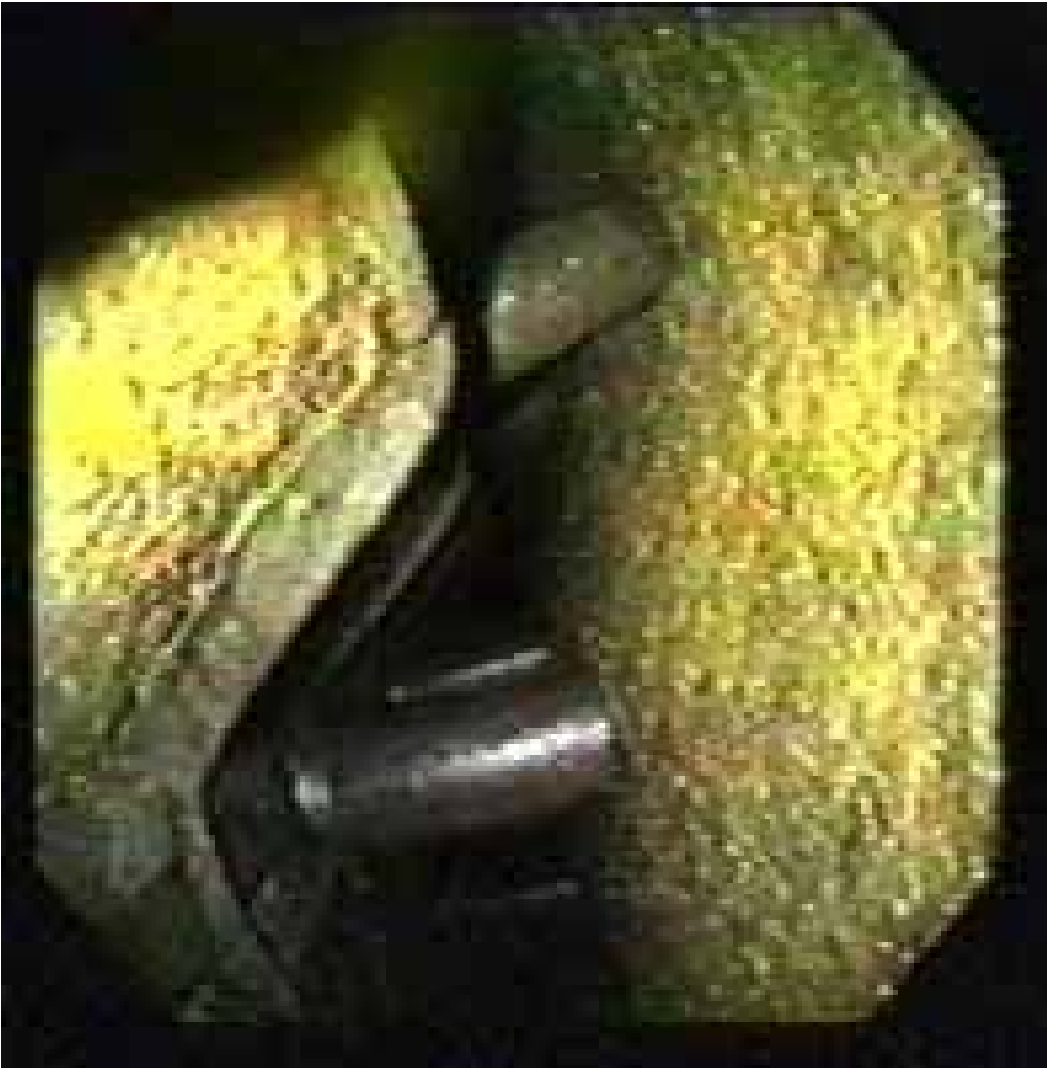
Figure 6 - Video Borescope Picture Showing Core Compression

Visual inspections were conducted to investigate the condition of the PED by excavating a small trench through the pavement shoulder at six construction projects (Table 4). The PED were located under the pavement edge joint at all test sites as required by the specifications. Samples of PED approximately 17 inches long were removed and pictures were taken of the PED. All PED experienced some amount of J'ing near the bottom varying from just the

bottom row of cusps to 5 or 6 rows. Some of the PED experienced compression in the top rows. The PED fabric material was compressed into core on all the PED. The PED left an impression of the rows of cusps in the soil when the sample was removed for permittivity testing. There was moist silt on the inside and wet soil on the outside of all of the PED varying from 2 inches high to 7 inches high. Water ran out of the PED after it was excavated at four of the sections. The outlet drain was blocked or damaged at two of the sections and it was not possible to locate the outlets at the other two sections.

- 1) Structural damage to the PED core occurs during installation if the PED is not in intimate contact with the side of the trench before any backfilling of the trench occurs. Backfill placed adjacent to or above the PED causes J'ing near the bottom and C'ing near the top. The possible causes for the lack of contact are:

Recommendations: Install PED in trenches so that contact is maintained with the side of the trench during backfilling. This may require reduction of tension on the PED from the installation equipment or hand placement of the PED in the trenches. Construction of the PED should be carefully inspected to reduce damage to the PED. DOT construction personnel should be apprised of PED construction specifications on a regular basis.

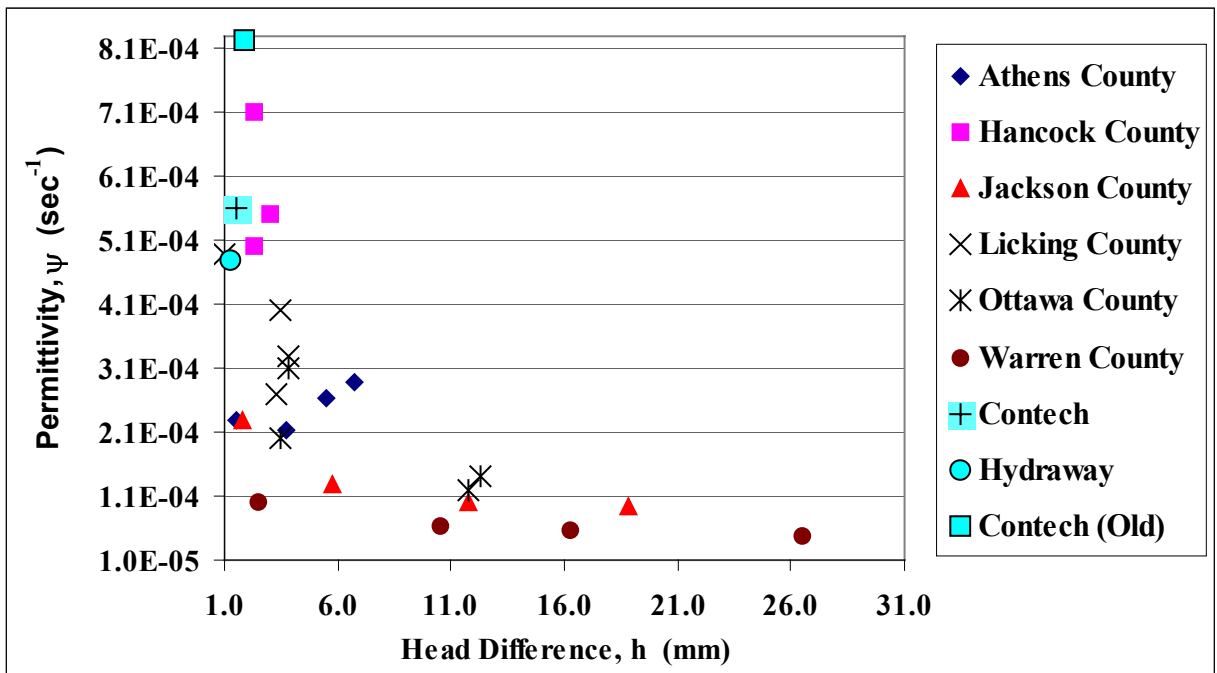
Each sample was tested at three or four different head differences using five trial measurements and the results of the five trials were averaged. A plot of average permittivity versus average head difference is shown in Figure 8. The figure also shows results of testing conducted at the University of Toledo on samples of PED obtained from the manufacturers. Permittivity was used for this research to test the effects of clogging of the fabric material. It was possible to establish a large head difference across the fabric for the dirty samples from Jackson, Ottawa and Warren Counties. For these three counties the permittivity decreased as the head difference increased. The PED from Hancock, Licking and Athens Counties does not follow this same trend. The sample from Hancock County was clean so results are very similar to the tests on the samples provided by the manufacturers. The PED from Licking County is much older and dirtier than Hancock County but the results are similar. The fabric material of the PED from Licking County may have been more permeable. The variation of flow rate is approximately linear so near laminar conditions existed during the testing. Based on the results of the testing, it is concluded that the permittivity of the fabric material is not significantly reduced by the soil.

Figure 8 - Average Permittivity, All Tests

- PED on the outside of the trench with a select backfill on the inside of the PED will reduce clogging and siltation of the PED.
- 6) Based on the permittivity testing, the permittivity of the filter material is not reduced significantly by clogging. Recommendation: PED can be used effectively for drainage, particularly if a select granular material is used for the backfill.
